A MUNICH LEGEND IS REBORN

— THE STORY OF '255 BMW'

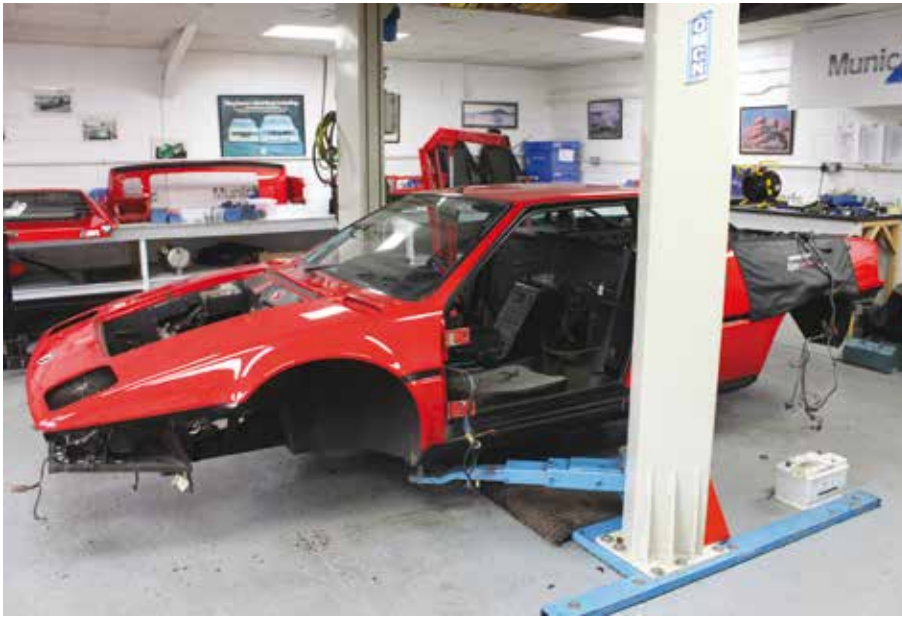
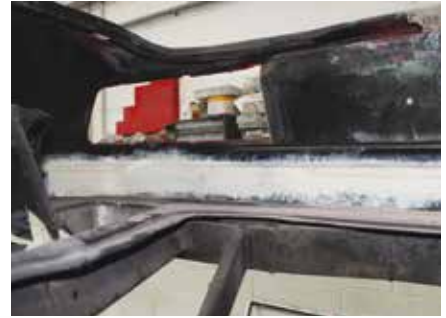
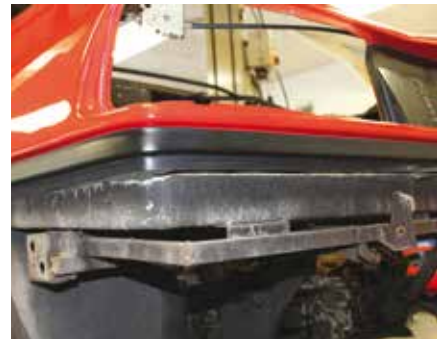
It's always worse than you think! Rear bumper is removed to reveal a huge fissure the length of the rear panel. The split is 'V'd' out, ground, roughened up for the glass fibre to be keyed on to the split. Firstly a course layer of fibre glass is added for strength, then a finer layer of mesh is added to give a perfect cosmetic finish. It is then coated and primed ready for paint.

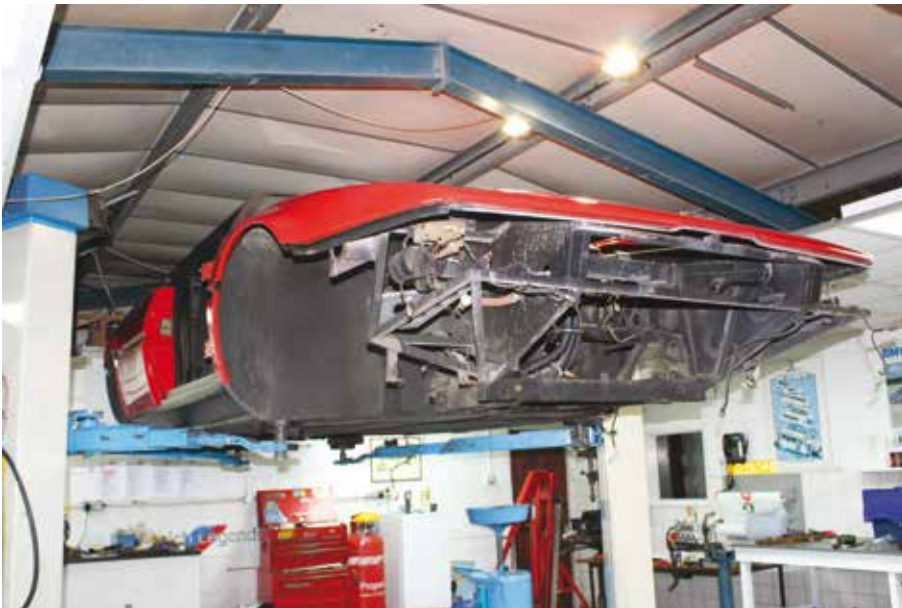
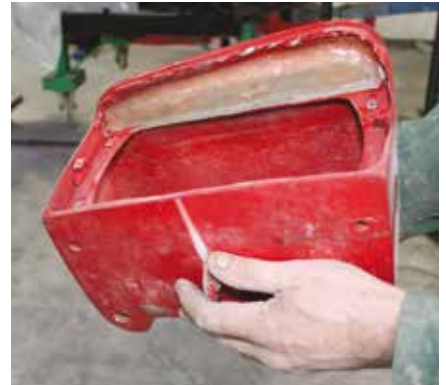
The workshop team immediately begin stripping the car and reporting back to BMW as to the condition. With an M1 it's the bits you can't see, the panels being fibre glass and therefore non corrosive. Even with the car in the air, very little is visible due to the whole underside being flat panels. The main body panels are peeled off, the underside covers are removed and the space frame begins to reveal itself.

Headlights were another known quantity. As they are one of the first places the oncoming weather impacts on the car (and they seem to be designed to retain water) they are in bad shape. These can be got to work on straight away while the rest of the car is stripped.

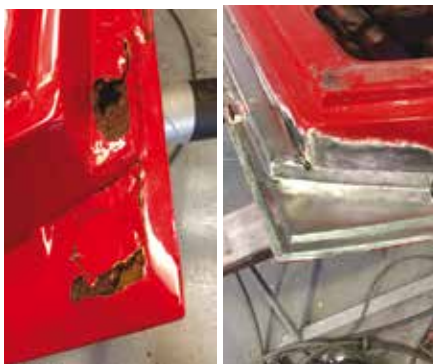
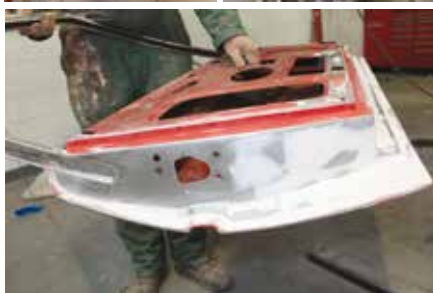
One known issue was the heavy corrosion in the lower part of the doors. The doors are immediately sent to the body shop to be stripped, re metalled, primed and made ready for painting.

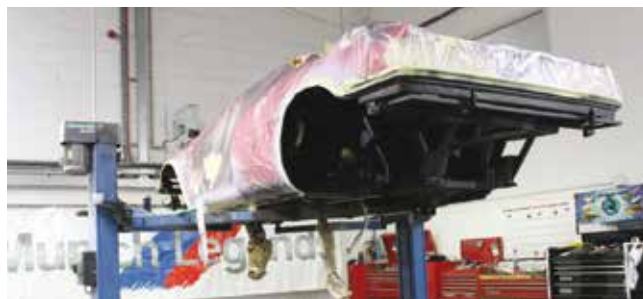
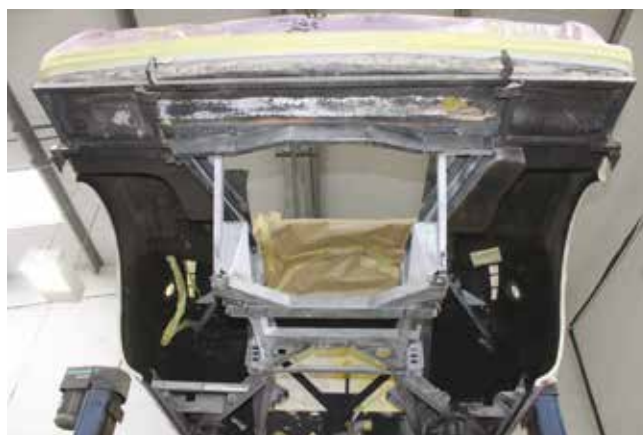
The tubular space frame and box sections are the main structural aspects of an M1. They're almost completely hidden from view, so it's only once the car comes apart you can see any damage or deterioration. In many ways this is the most vital part of the restoration. Once the car is back together, the space frame is hidden again, and the structural integrity of the car relies upon this job being done properly, to last at least another 35 years. The metal structure is stripped of paint and inspected, revealing significant corrosion. The affected areas are re metalled, treated and primed. The rest of the car is then covered with protective film and masked up, and the whole space frame can then be painted in the correct factory finish.

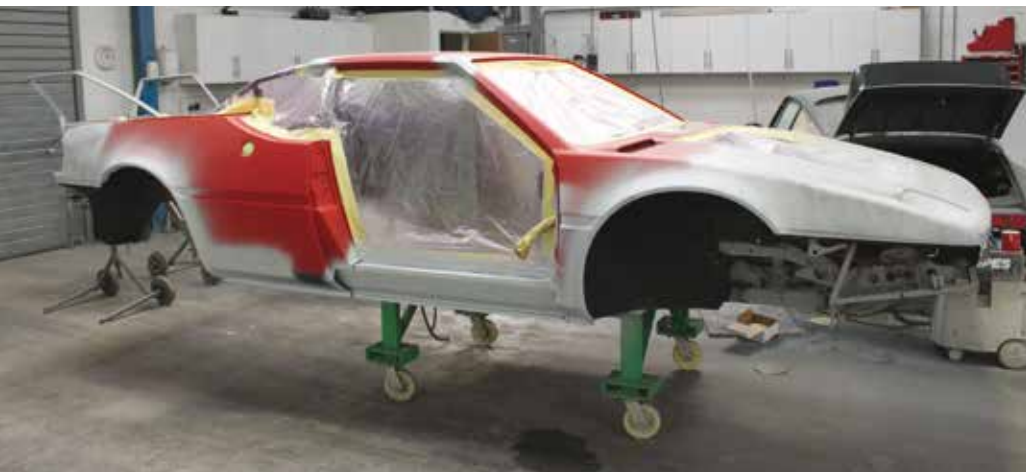
Finally the main car is primed and ready for painting. A base coat is applied for the colour followed by a clear PPG lacquer to give depth to the finish and protect the paint. A decision was made to use a modern paint process for longer durability and better finish

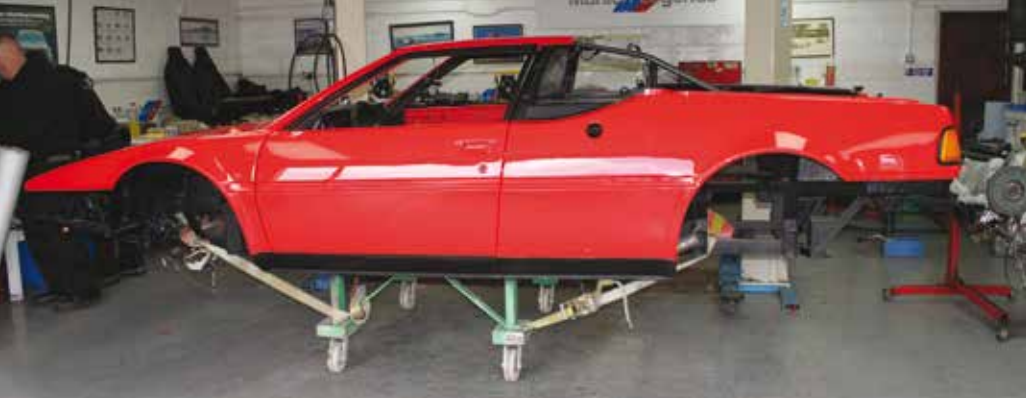
The painted shell arrives back in the main workshop on its specially adapted trolley. The refit can begin, but more than any other car the M1 is fragile in this state, so watch out! Is it a race car or a pick-up truck?

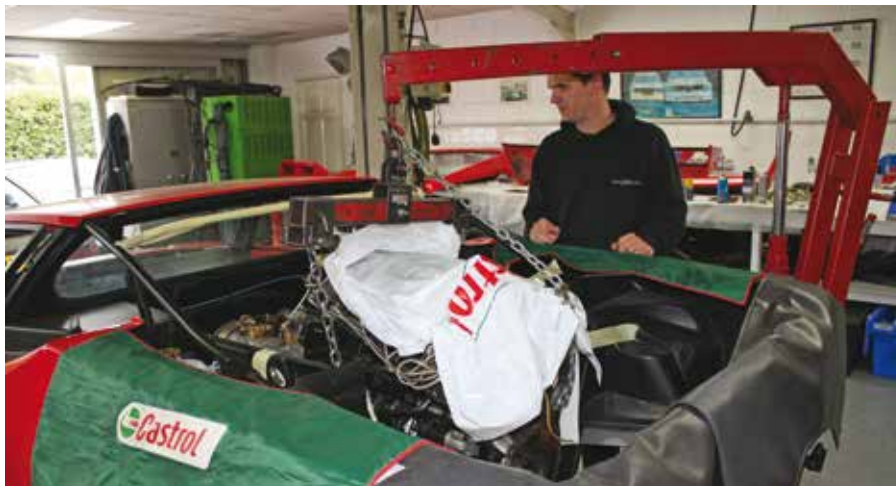
The engine is hung on the hoist and gently lowered in to the engine bay. This takes an inordinate amount of time to guide correctly, and three men. As the engine strains on the chains of the hoist, it is raised past the fragile fibre glass – freshly repaired and painted – rear panels.

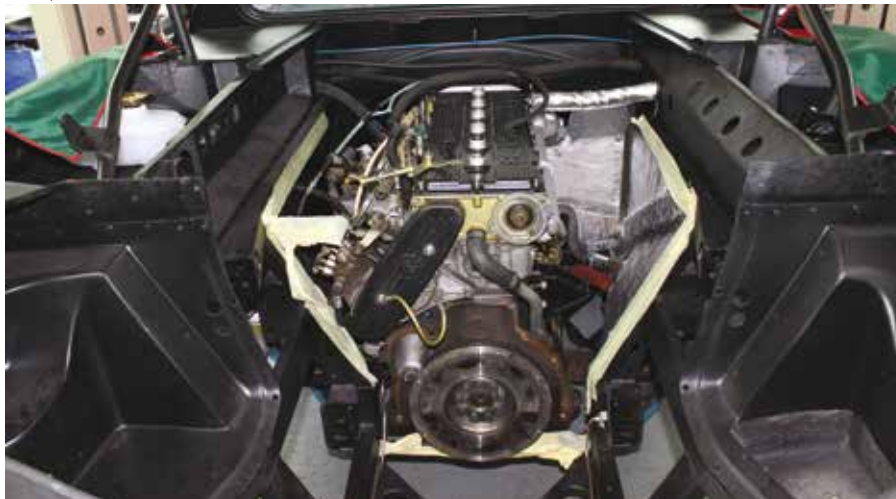
The inside of the engine bay is masked up to protect the newly restored interior from any minor scratches or damage as the engine is inched slowly into place.

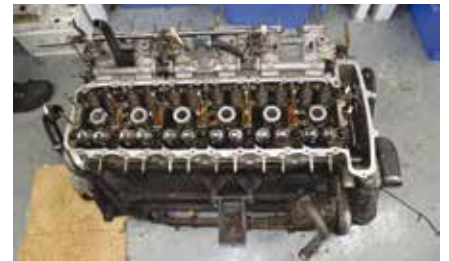
Meanwhile that fabulous M88 engine is tested, stripped and examined. Compression tests reveal poor figures so the decision is made to strip the head and investigate the reason. Closer examination reveals that the valves weren't seating properly due to excessive carbon build up. The valves were removed, checked and measured, cleaned and relapped.

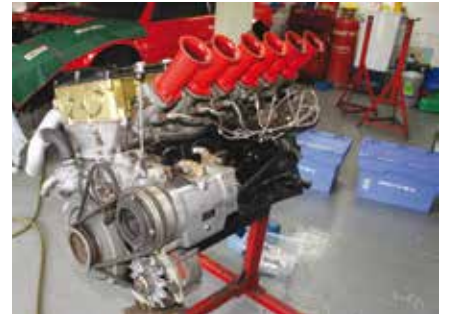
The engine can now be rebuilt using all new seals, gaskets and other ancillaries, with every component restored to its original factory finish. This is what a race engine looks like in a road car, complete with trumpets!

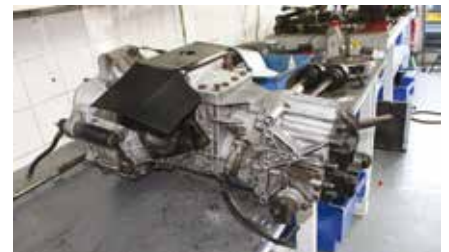
The transaxle - gearbox and differential - are now ready to be mated, having been fully overhauled, resealed and refinished. Best not get that toothbrush mixed up at home!

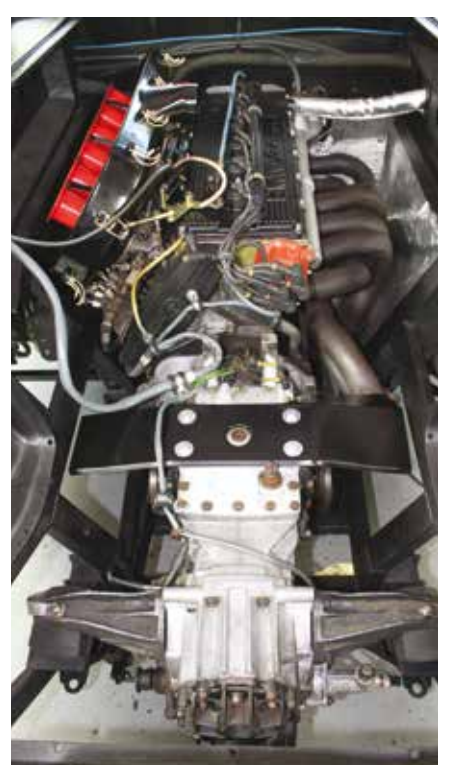
Finally the engine is seated precisely and can be mated to the transaxle. After a stressful stage in the project, the engine bay is starting to look complete as wiring and plumbing is carried out.

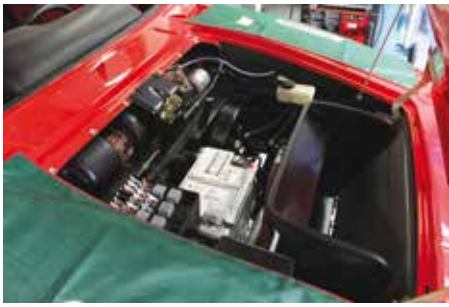
The front compartment of the M1 begins to be assembled and connected as the cooling system is installed and the fuse box and electrics are connected up. The M1 cooling system is of course a one off for BMW, as the radiator – mounted up front – has to send and return coolant to the engine mounted in the rear. As the pipes run through the cabin, every millimetre has to be checked and rechecked. M1s are notorious for coolant leaks inside the car, which require the interior to be stripped to trace the problem.

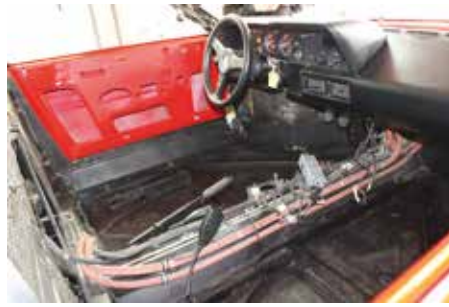
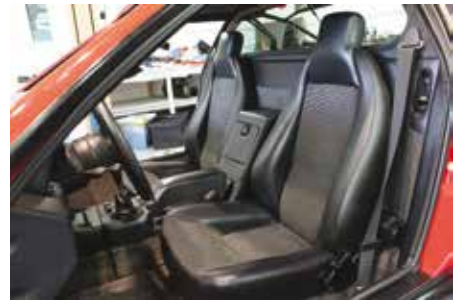
The seats are returned from the trimmers, having been re-stuffed, the bolsters repaired and the leather and fabric treated. The aim was to keep strictly to the original, so it was decided to restore the interior rather than replace it. Great care is taken to clean and inspect every inch of the interior, rugs, trim and switch gear, to ensure it looks as good as the day it left the factory.

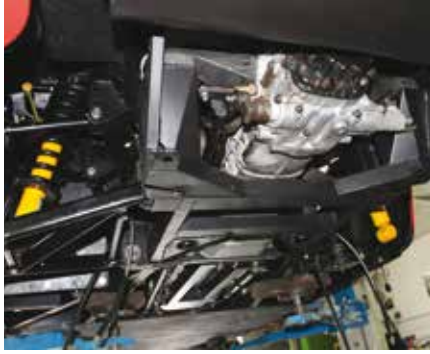
The rebuild nears completion, it's time for the brakes to be fitted and connected along with checks on all fluid hoses and lines. Then the undertrays and covers will be fitted, and the magnesium Campagnolo wheels, freshly back from the specialist refurbishment, finally make the M1 a movable beast.

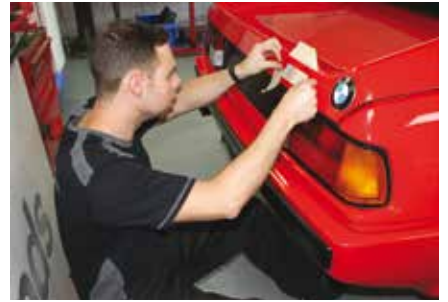
James puts on the finishing touches. Every aspect of this restoration has to be perfect, so even studying archive photographs for the exact spot for the stickers takes time - engine bay, front compartment and of course the iconic M1 sticker for the tail gate. Steady, James!
